## USAAMRDL TECHNICAL REPORT 73-20

# MANUFACTURING METHODS TECHNOLOGY (MM&T) FOR BALLISTIC-TOLERANT FLIGHT CONTROL COMPONENTS

May 1973

**CONTRACT DAAJ02-71-C-0062**  
**WHITTAKER CORPORATION**  
**RESEARCH AND DEVELOPMENT DIVISION**  
**SAN DIEGO, CALIFORNIA**

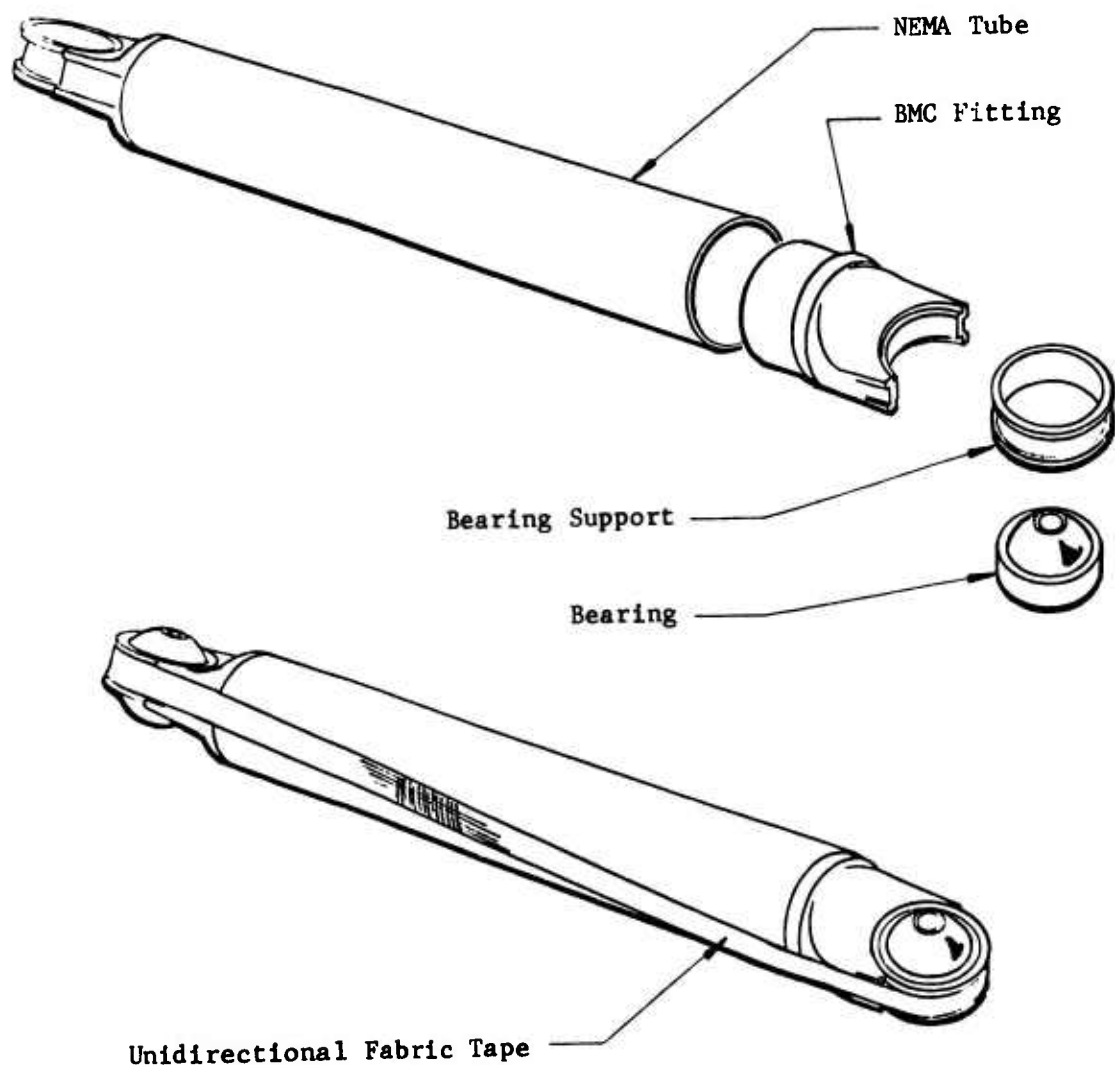
Figure 1. Connecting Link Assembly.

Based on these assumptions, preliminary design concepts for each of the four components were prepared. These preliminary design concepts are shown in Figures 1 through 4.

Figure 1 is a view of the details comprising the connecting link component. It consists of two epoxy BMC molded end fittings, one NEMA-grade round tube, two bearing supports and swivel bearings, and a unidirectional epoxy/glass fabric strap.

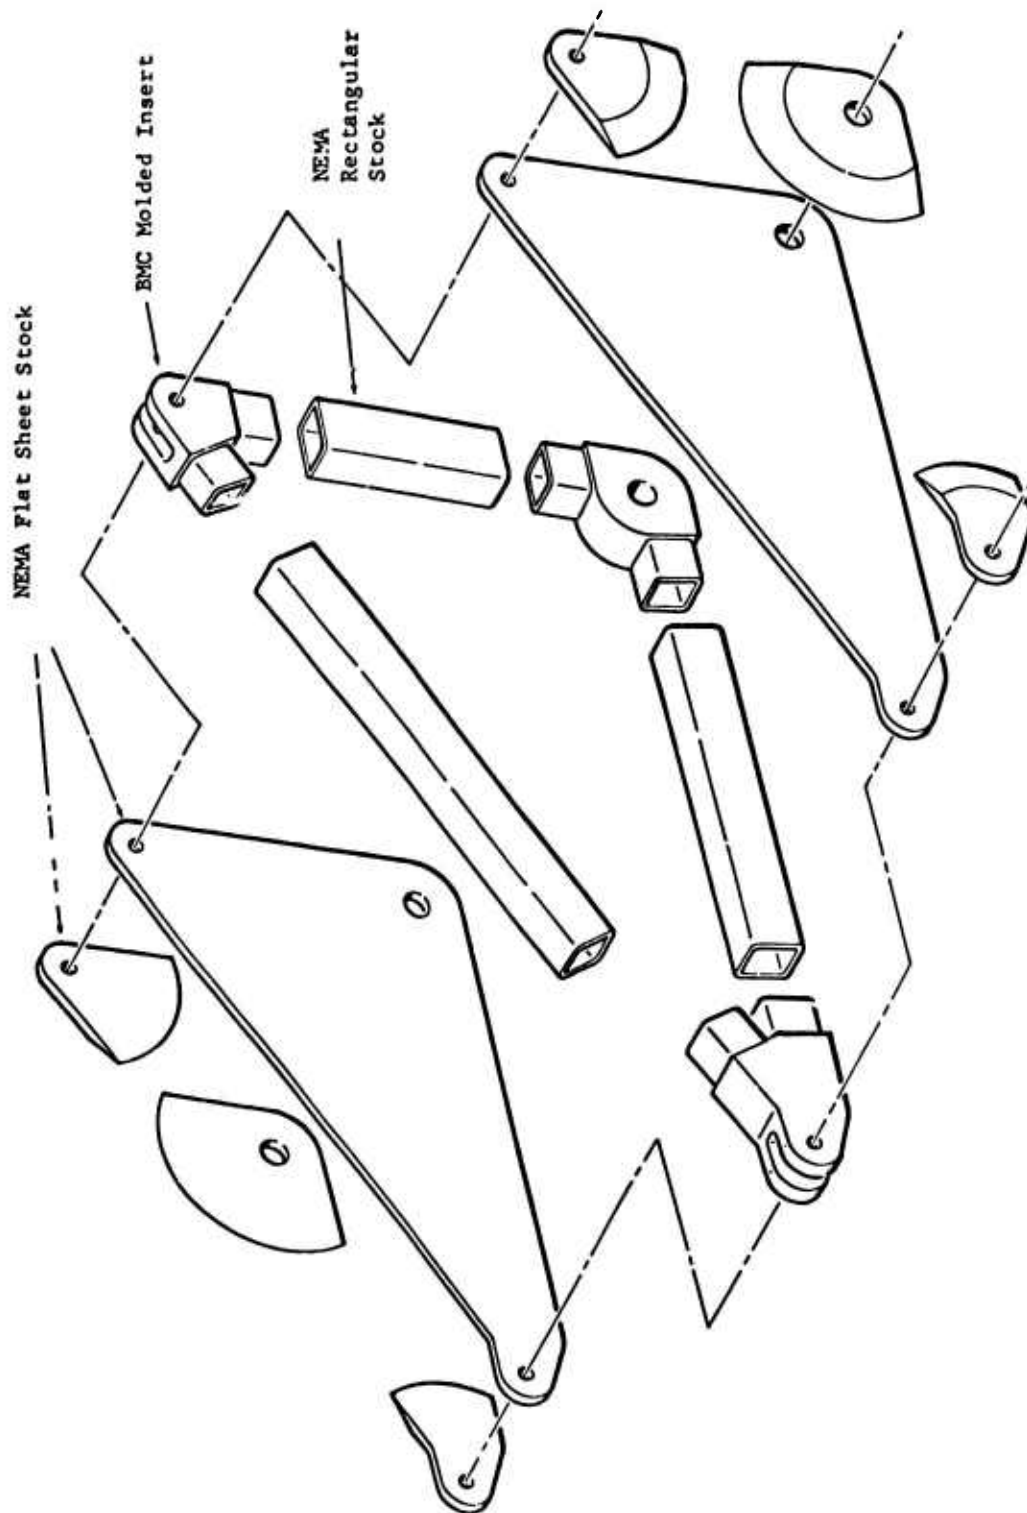
The forward bell crank assembly shown in Figure 2 consists of NEMA-grade epoxy/fiber glass square tubing, two flat face sheets, and three epoxy BMC molded fittings. Comparing this design with the Vertol design, the foam core has been removed from the center of the bell crank, the fittings are molded to the final configuration instead of being machined, and the continuous fiber glass reinforced elements are obtained as precured stock shapes and sheets.

Figure 2. Exploded View of Forward Bell Crank.

Figure 2 is an exploded view of the details comprising the forward bell crank assembly. As shown, the forward bell crank is a triangular box containing three epoxy BMC fittings at three corners. Two of the fittings are clevis-type fittings and the third a pivot fitting. Between the three fittings are three square NEMA-grade glass/epoxy tubes. Covering the two sides of the triangle are sheets of NEMA-grade sheet stock and NEMA-grade doublers at the fitting locations.

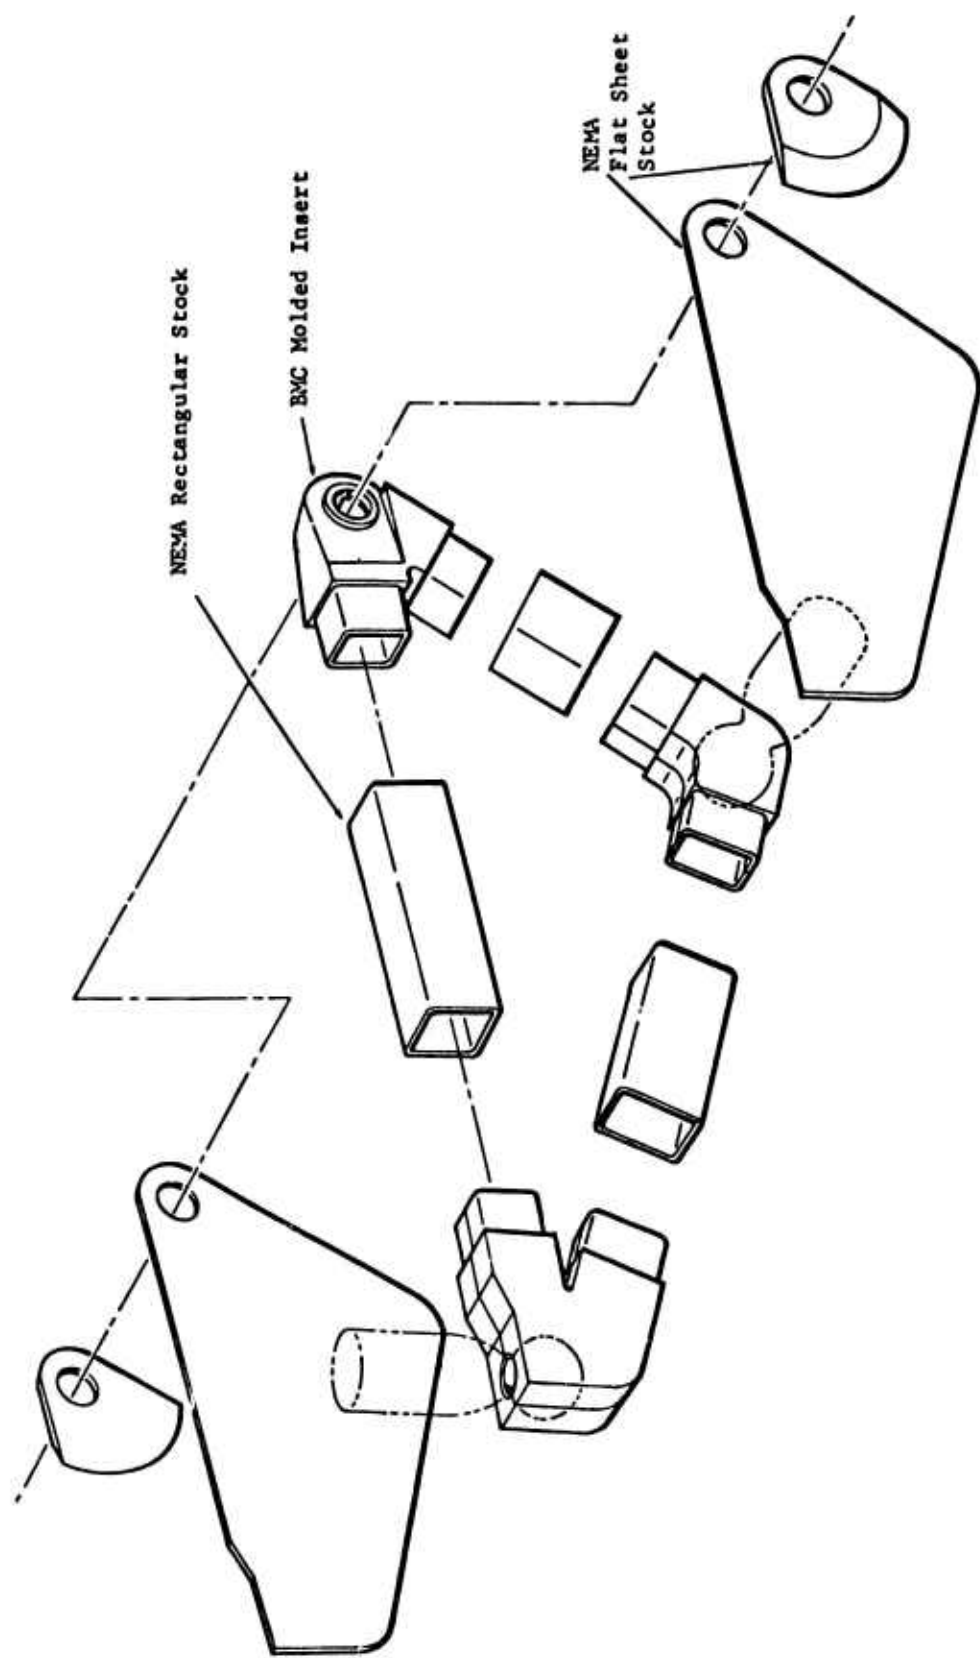
Figure 3, the aft bell crank assembly, consists of two molded ball rod ends, three sections of NEMA grade epoxy/fiber glass rectangular tubing, two epoxy BMC socket fittings, one epoxy BMC pivot fitting, and two NEMA-grade epoxy/fiber glass face sheets. Comparing this with the Vertol design, the internal foam core has been removed; all ball and socket joints and pivot fittings are matched metal die molded to the final configuration rather than filament wound or machined.

Figure 3. Exploded View of Aft Bell Crank.

Figure 3 is an exploded view of the details comprising the aft bell crank assembly. Basically, the aft bell crank consists of a triangular box to which two rod end/retainer assemblies are installed. The triangular box consists of three epoxy BMC molded fittings, two of which contain sockets for the ball rod ends and the third a pivot fitting. Between each of the three fittings are three rectangular NEMA-grade tubes. Covering both sides of the triangular box are sheets of NEMA-grade sheet stock. On each side of the pivot fitting surfaces and around the bearing support is a NEMA-grade flat sheet stock doubler.

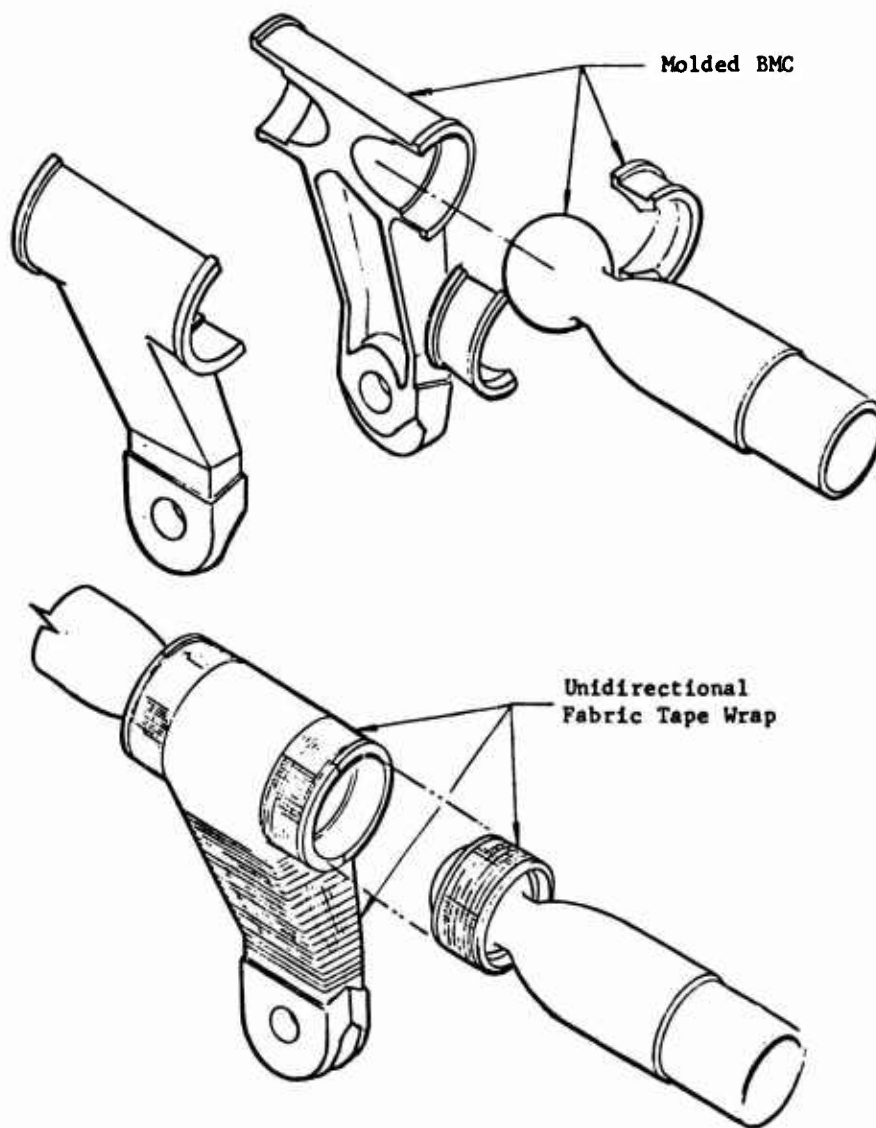
Figure 4. Exploded View of Idler Arm and Rod End Assembly.

Figure 4, which shows the concept for the design of the idler arm and rod end assembly, consists of two BMC molded rod end ball and socket details, an epoxy BMC idler arm assembly, and a unidirectional epoxy/fiber glass tape overwrap around the idler arm and the ball and socket joint. Comparing this design with the Vertol designs, the ball rod ends are matched metal die molded rather than filament wound, and the idler arm assembly does not contain foam and has been overwrapped with continuous glass fabric tape rather than unidirectional fiber glass roving.

As shown in Figure 4, the idler arm consists of two molded BMC halves which, when assembled, are overwrapped with unidirectional, epoxy impregnated fabric tape both around the arm section and around the outboard edges of the socket joint.

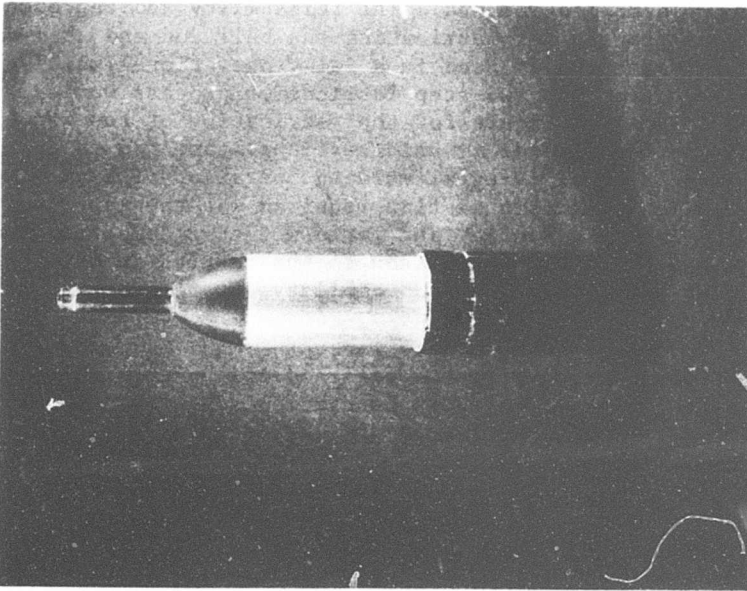
Figure 5. Mandrel for Unidirectional Shell.

A subassembly technique proved to be extremely successful. The layers of the unidirectional prepreg were applied to a mandrel, shown in Figure 5, and cured in place. This shell (Figure 6) was then removed and sandblasted on the outer surface, followed by MEK solvent degreasing, and inserted into the matched metal tool. The molding operation with the BMC material was then accomplished with the unidirectional shell already cured. Figure 7 shows a molded rod end. The reliability and reproducibility of this two-step process for fabricating the ball rod end were well within the 5% scrap factor normally used in a fully operational manufacturing line. While the developed two-step fabrication process would appear to involve additional man-hours for the fabrication of the rod end detail, the layup of the three plies of unidirectional tape had to be performed whether it would be an integral molding operation or a two-step molding operation. The only additional time required was the labor to remove the cured shell from the mandrel and perform the sandblasting and solvent degreasing operations. In comparison to the results in developing an integral molding process, the reproducibility and reliability of the two-step process are very successful.

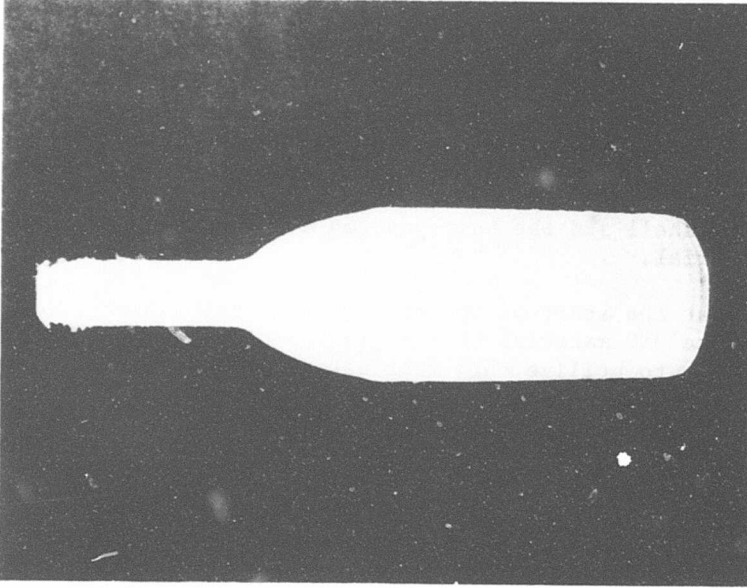
Figure 6. Cured Shell With Rough Bonding Surface.

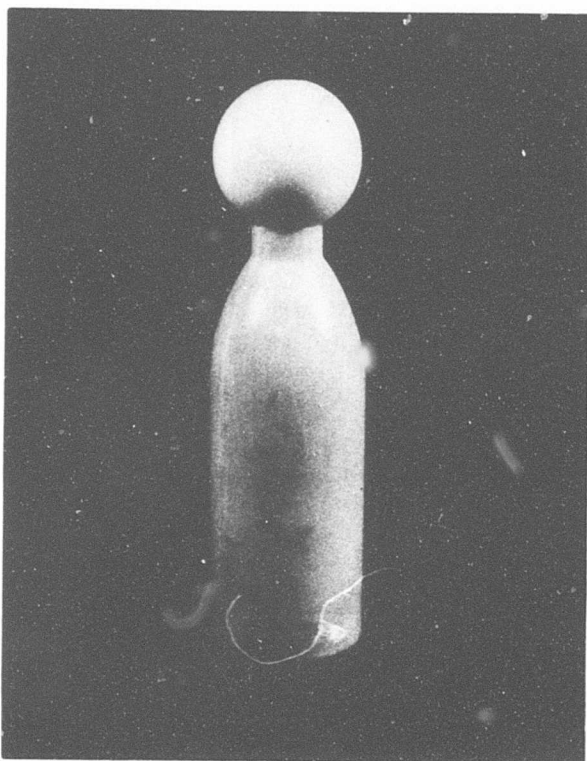
Figure 7. Molded Rod End.

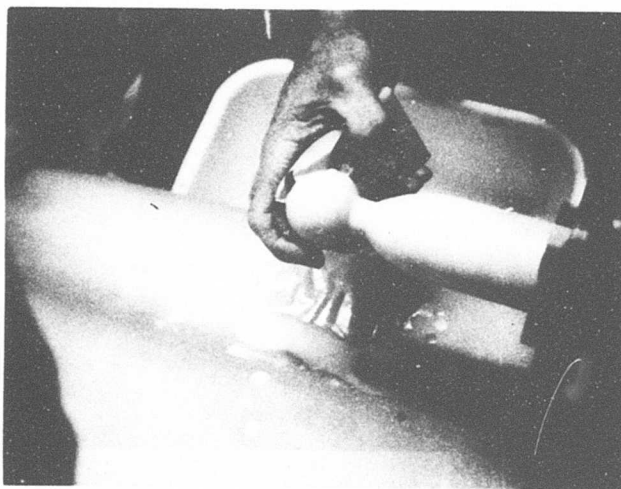
Figure 8. Honing to True Sphere.

After molding of the rod end assembly, the ball end of the detail is fine honed to a true spherical radius, as shown in Figure 8. After accomplishing this, the honed surface is cleaned and degreased in MEK and spray-coated with multiple layers of Teflon loaded polyurethane paint to reduce the friction between the ball and socket interfaces (Figure 9). In order that the tolerance of the fit between the ball and socket be maintained, an overthickness of paint is applied to the ball rod end. This overthickness is then honed to a true spherical radius after the paint has been fully cured (Figure 10).

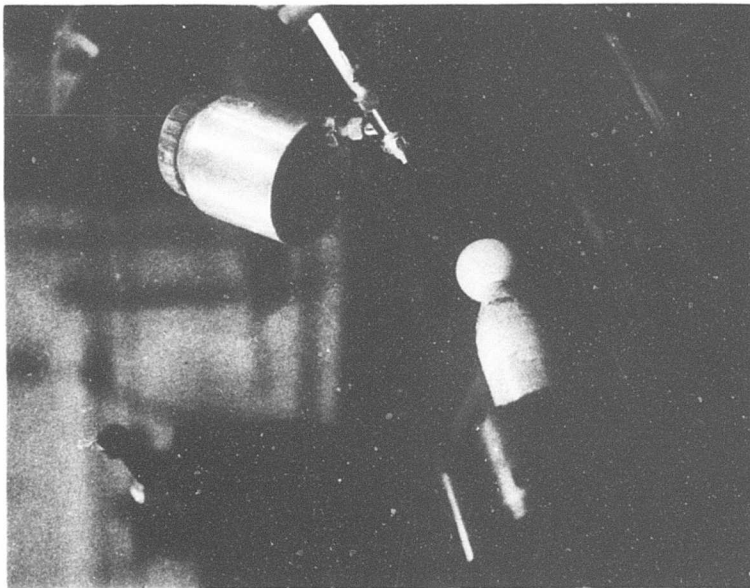
Figure 9. Applying Paint to Ball Surface.

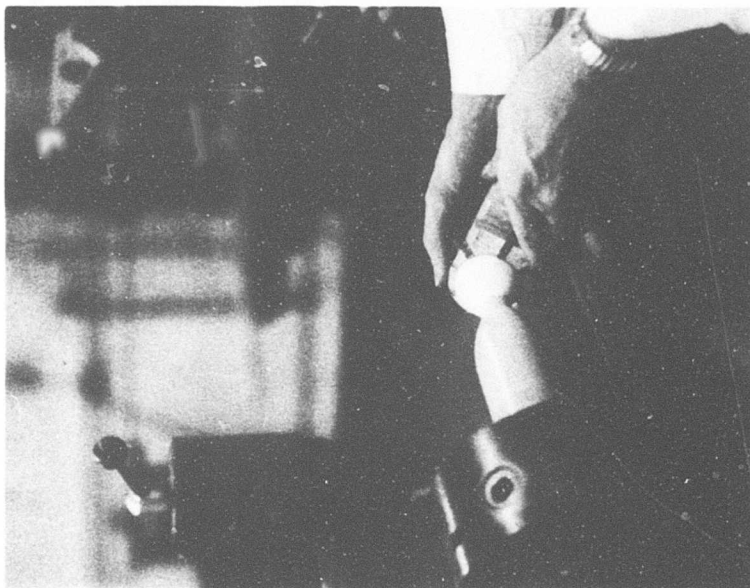
Figure 10. Honing Painted Surface.

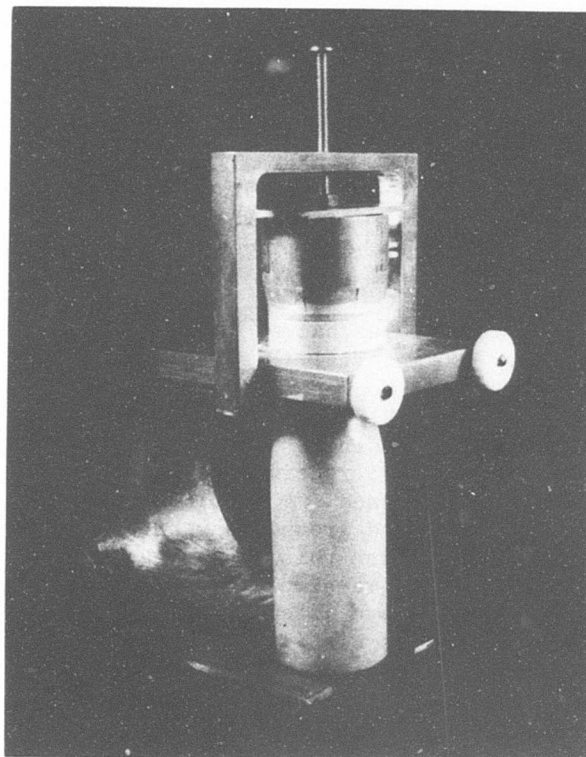
Figure 11. Installing Retainer Ring Around  
Ball Rod End.

After final honing of the painted ball surface, the retainer ring halves are positioned around the neck of the ball socket and overwrapped with two layers of epoxy impregnated 143-style glass fabric. The retainer ring halves are positioned in a fixture which holds them in a true circular alignment (Figure 11). The ball is permitted to locate on the mating retainer surfaces and is forced against the retainer to maintain proper fit. Once this has been accomplished, the two layers of prepreg tape are wrapped in the recess of the retainer and overwrapped with cellophane shrink tape. The entire assembly is placed in an oven and cured for 1 hour at 250°F.

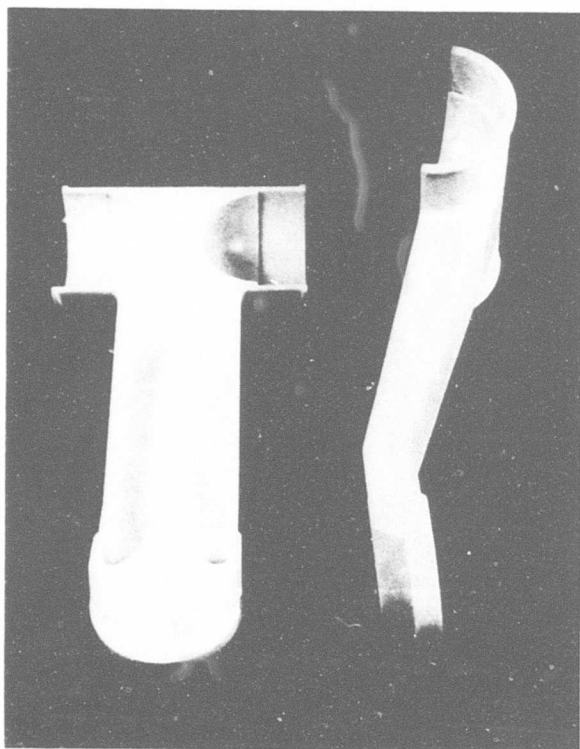
Figure 12. Molded Idler Arm Halves.

The fabrication of the two idler halves is performed by matched metal die molding with the epoxy BMC material (Figure 12). The two halves are assembled with the ball socket fixtures, which are a part of the aft bell crank assembly fixture (Figure 13). These serve to position and align the socket half during the bonding of the idler arm. Subsequent to the bonding, the areas which are to receive the unidirectional reinforcement are sandblasted and MEK degreased. A fabric tape pattern is cut from the broadgoods material and wrapped around the three areas shown. Three plies of fabric are used to accomplish this task. The wraps around the outboard socket ends of the idler arm are simply overwrapped with three layers of cellophane shrink tape. The arm assembly, which contains four flat edges, is covered in these flat areas with 1/4-inch cork material which is chamfered at the corners to prevent wrinkling during cure. This in turn is overwrapped with three layers of cellophane shrink tape.

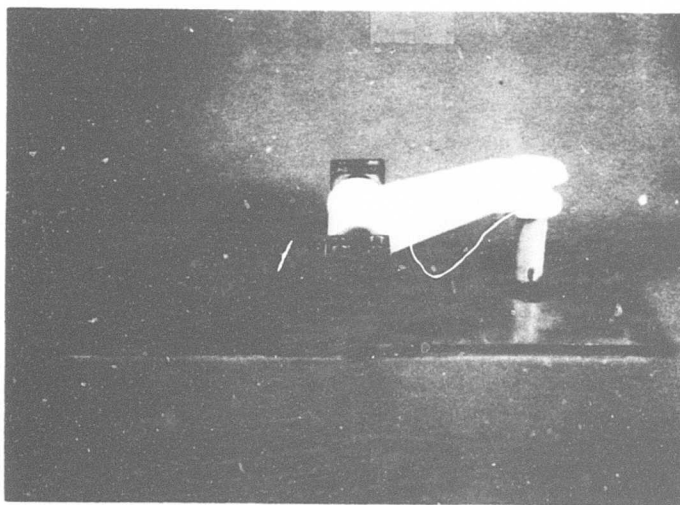
Figure 13. Bonding Idler Arm Halves.

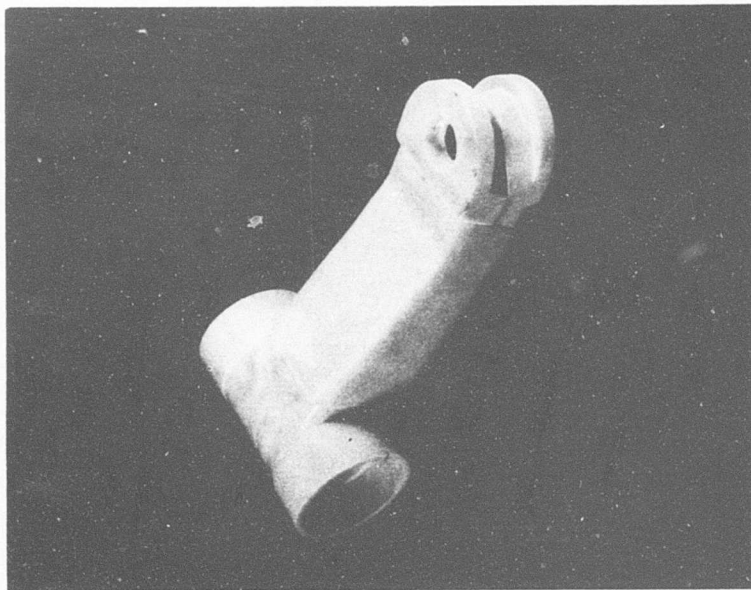
Figure 14. Cured Idler Arm.

The cured idler arm assembly (Figure 14) is positioned back on the curing fixture, and the hole which will contain the bearings and bearing spacer is drilled.

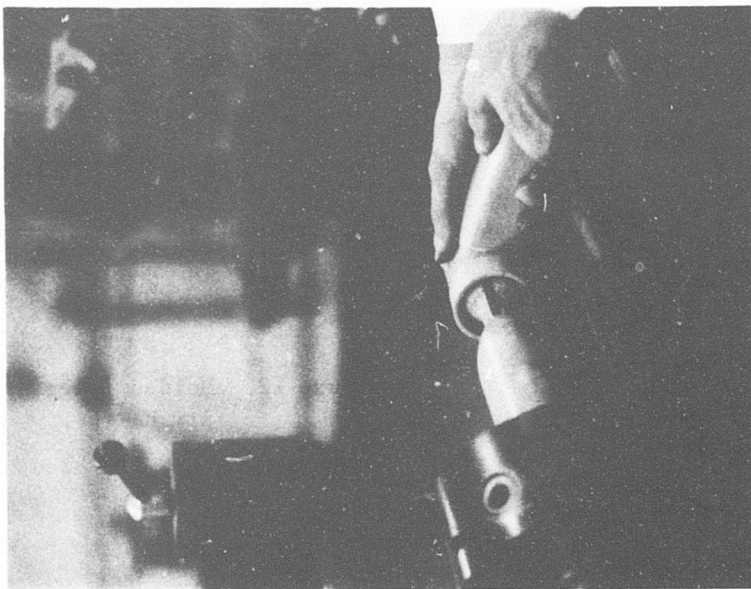
Figure 15. Honing of Idler Arm Socket.

The final operation on the idler arm assembly is the honing of the socket surface to a true sphere. This operation is shown in Figure 15.

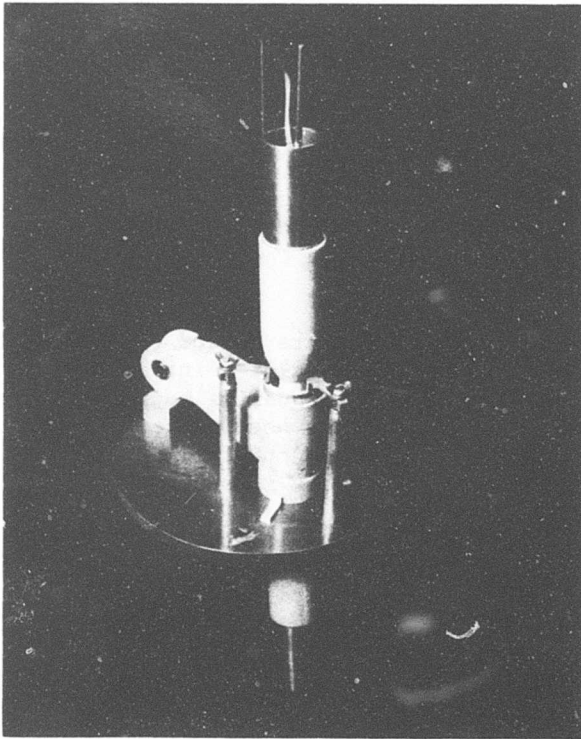
Figure 16. Assembly of Rod End Idler Arm.

The assembly of the rod end and idler arm details consists of installing rod end assembly and retainer into the idler arm socket. This is accomplished by adhesive bonding in a fixture, as shown in Figure 16.

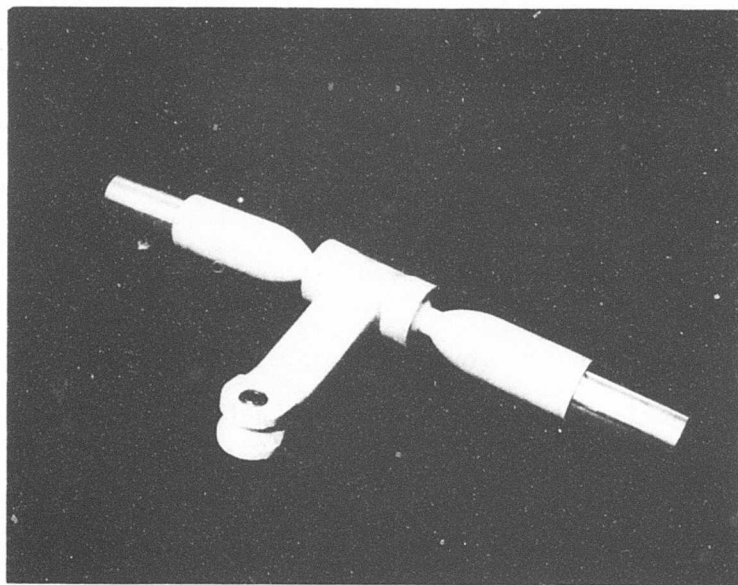
Figure 17. Full Assembled Rod End Idler Arm Component.

The final assembly on the rod end idler arm component is the installation of the bearings. The two bearings and the spacer are bonded into the hole at the lower portion of the idler arm detail. Figure 17 is a picture of a fully assembled rod end idler arm assembly.

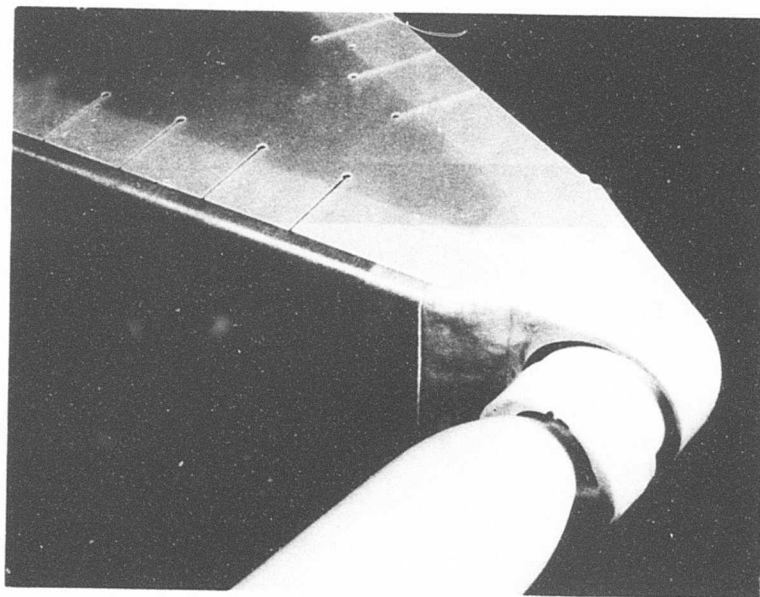
Figure 18. Typical Assembly of Aft Bell Crank Details.

The three corner fittings for the bell crank box are molded from epoxy BMC material. The two fittings which contain a socket joint are molded as one final detail. The hole which contains the bearing support tube in the pivot fitting is drilled after the molding has been prepared. The NEMA-grade flat sheet stock and tubular shapes are cut from stock material to the desired configuration. Typical assembly is shown in Figure 18.

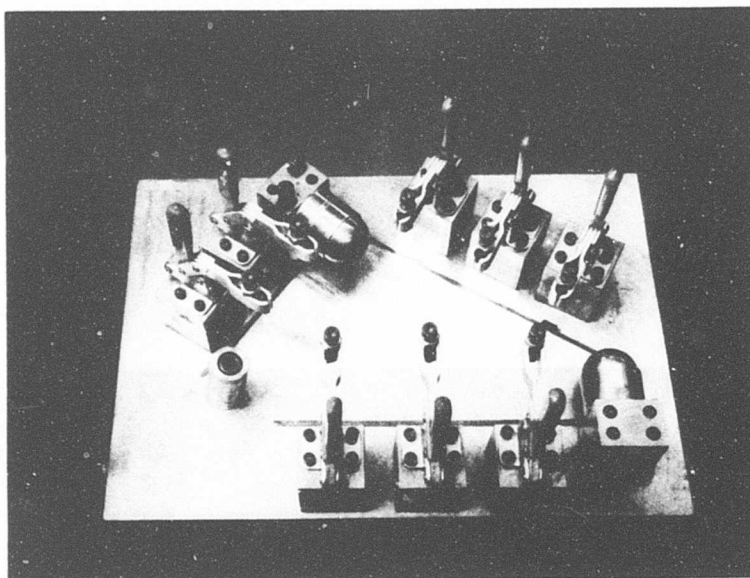
Figure 19. Aft Bell Crank Assembly Fixture.

The assembly of the main bell crank triangular box is accomplished by adhesive bonding all details in an assembly and bonding fixture shown in Figure 19. Figure 20 shows the bell crank installed in the fixture during the bonding operation.

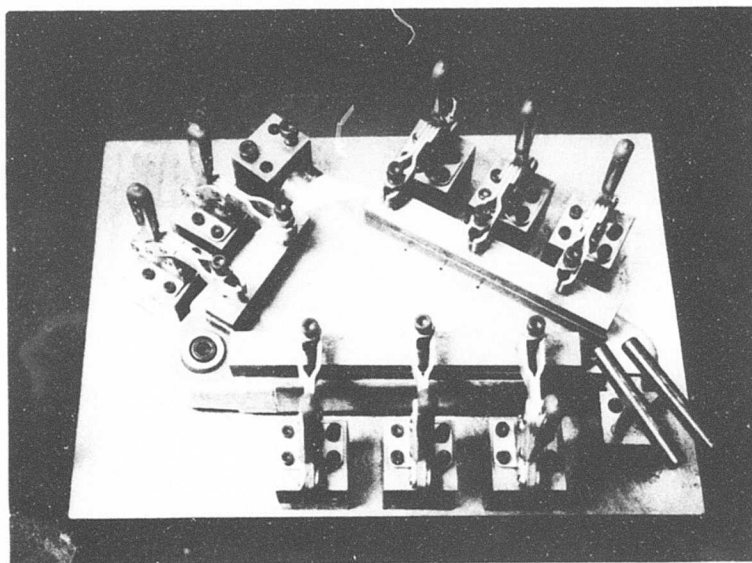
Figure 20. Bonding of Aft Bell Crank Box.

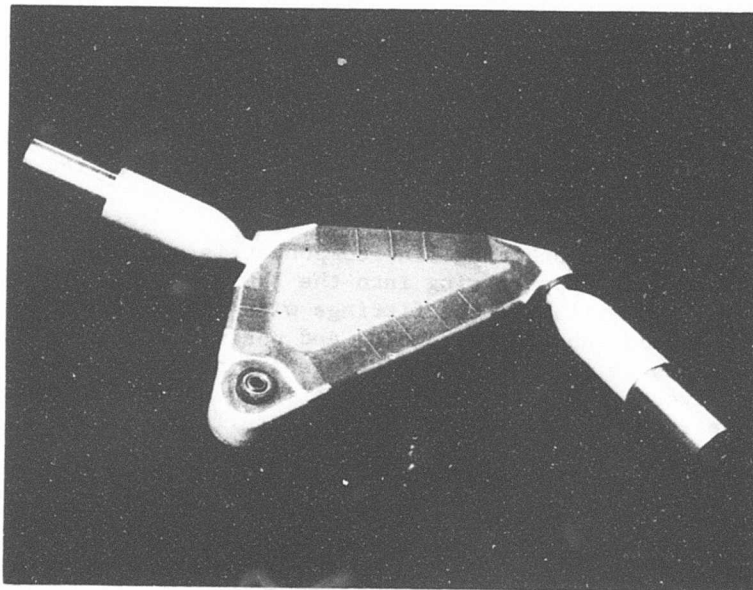
Figure 21. Fully Assembled Aft Bell Crank Component.

Figure 21 is a picture of a fully assembled aft bell crank assembly.

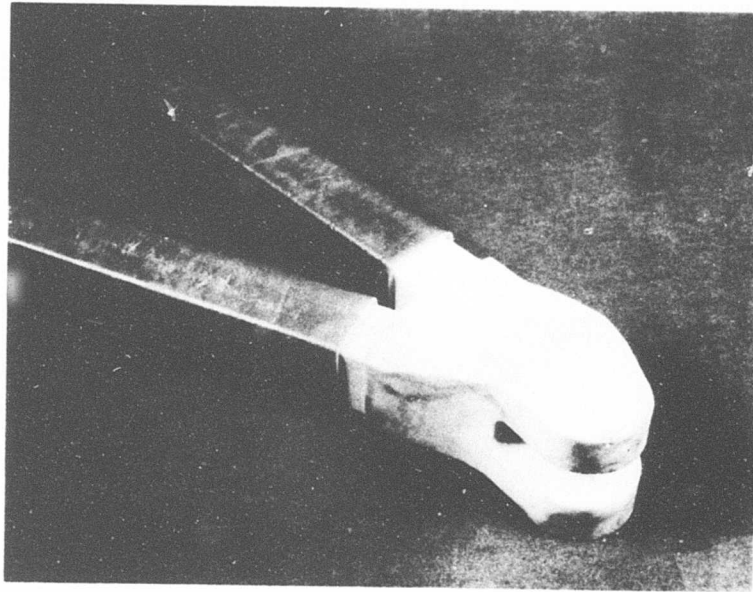
Figure 22. Typical Tube Fitting Assembly.

The NEMA-grade face sheets, doublers, and tubes are cut from stock tube and sheet material and assembled to the fittings, as shown in Figures 22, 23, and 24.

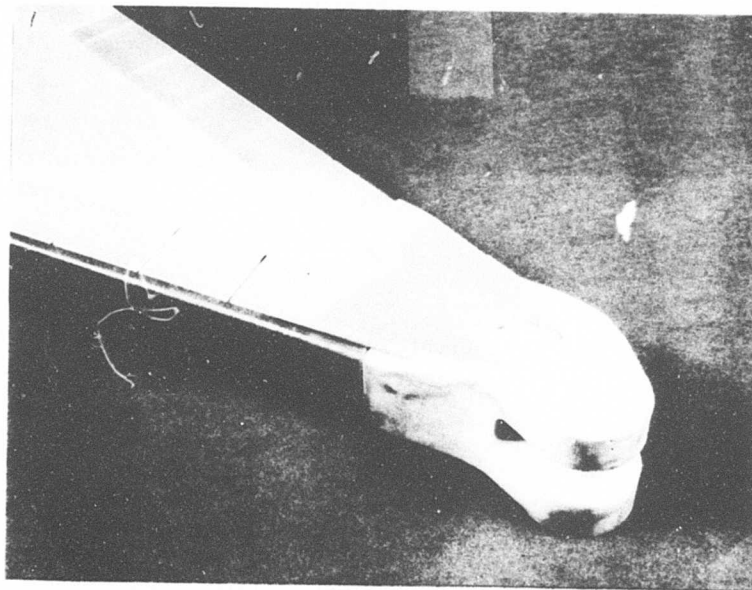
Figure 23. Installation of Face Sheet and Doubler.

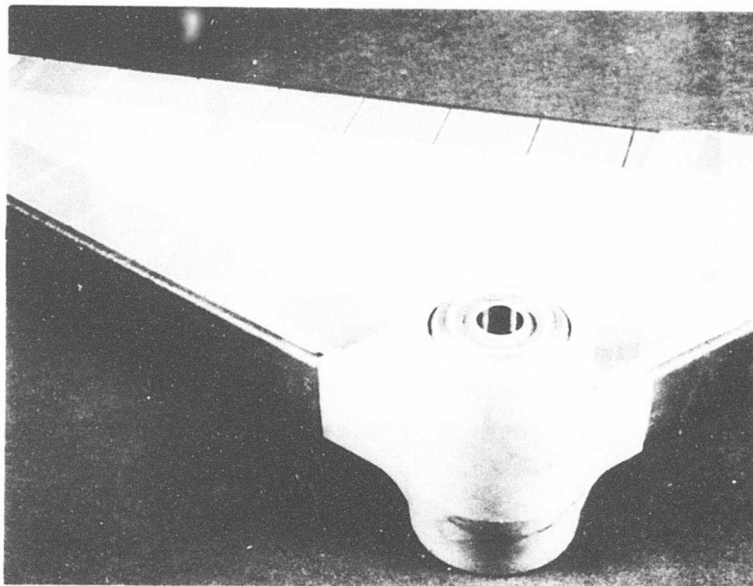
Figure 24. Pivot Fitting Installation.

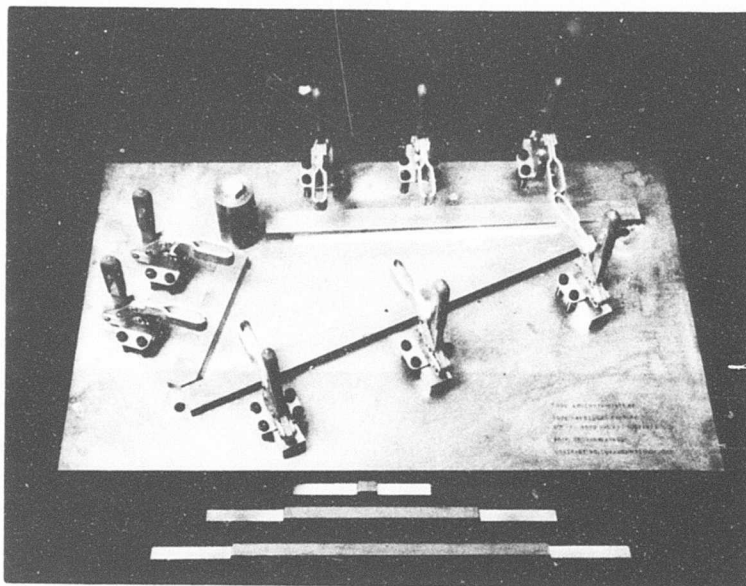
Figure 25. Forward Bell Crank Bond Fixture.

The assembly of the details is accomplished in the assembly and bonding fixture shown in Figure 25. Figure 26 is a view of the fixture containing the forward bell crank assembly during the bonding operation. Figure 27 is a picture of the fully assembled forward bell crank component.

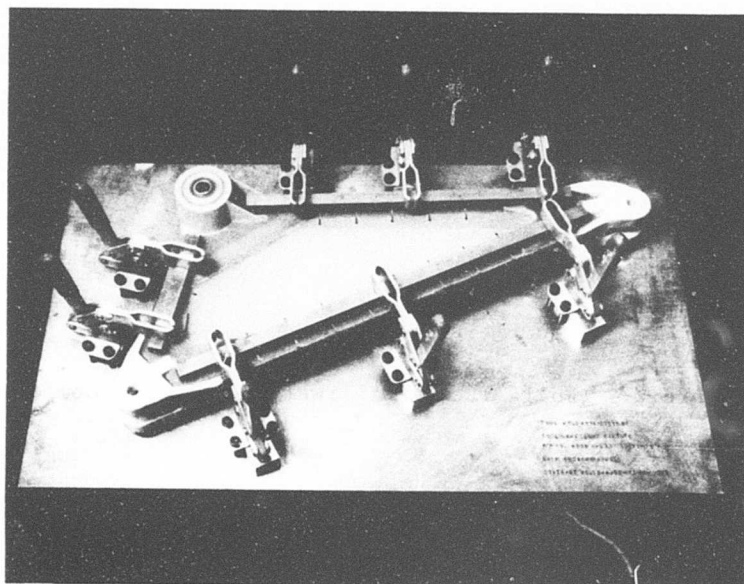
Figure 26. Assembly of Forward Bell Crank.

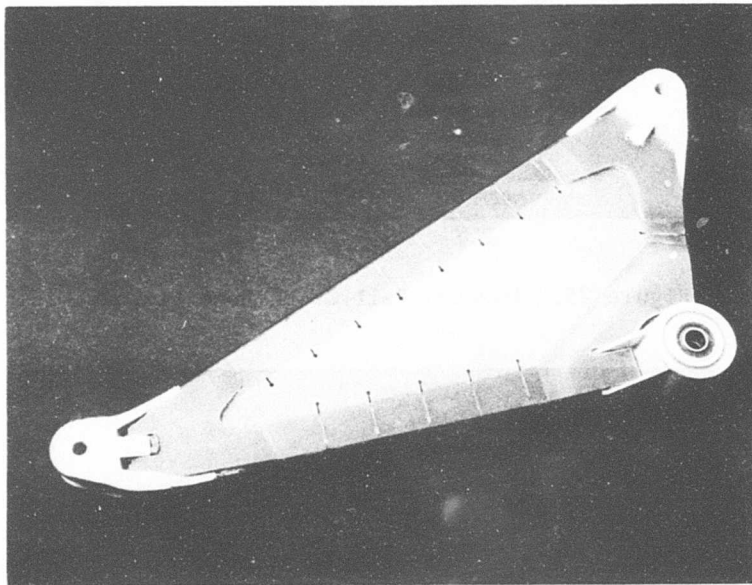
Figure 27. Full Assembled Forward Bell Crank Component.

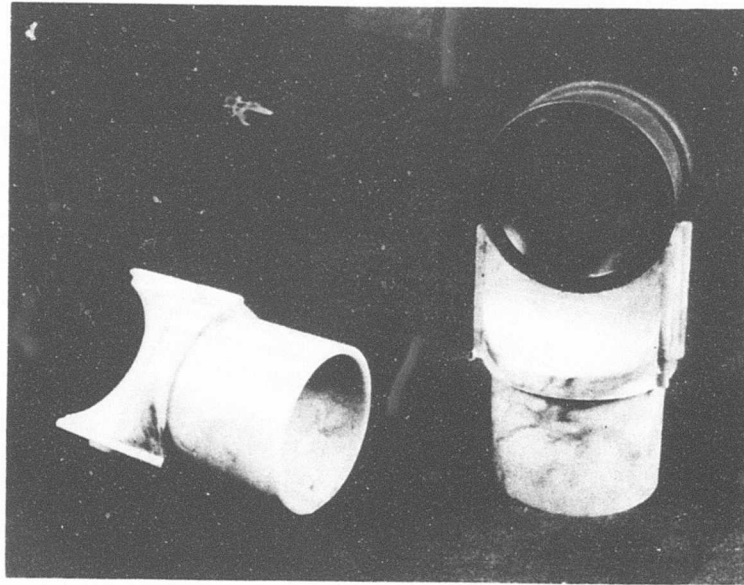
Figure 28. Fitting and Bearing Support.

The assembly of the connecting link component is performed first by bonding the bearing support ring into the BMC fittings (Figure 28). While this is being accomplished, the fittings with the bearing support ring and the NEMA-grade tube are assembled and positioned in the fixture, as shown in Figures 29 and 30. The fittings are bonded inside the tube and the unidirectional glass fabric tape is wound around the end of the bearing support rings and laid on the tube surface.

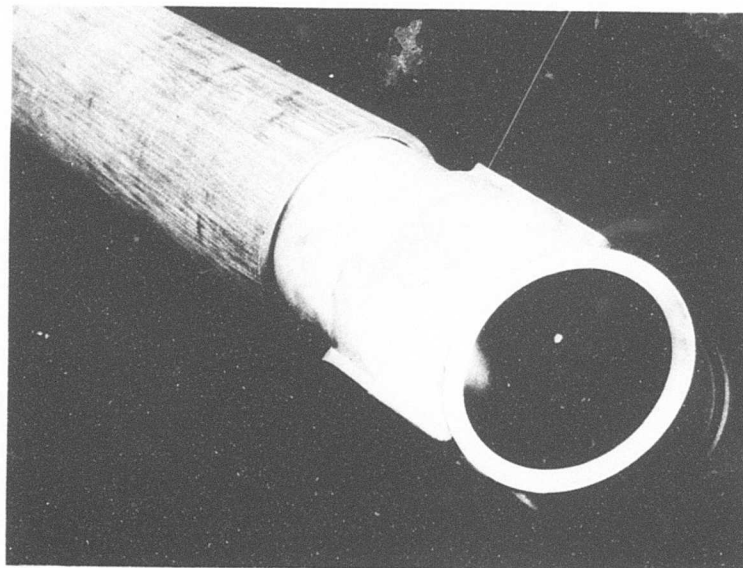
Figure 29. Installation of Tube and Fitting.

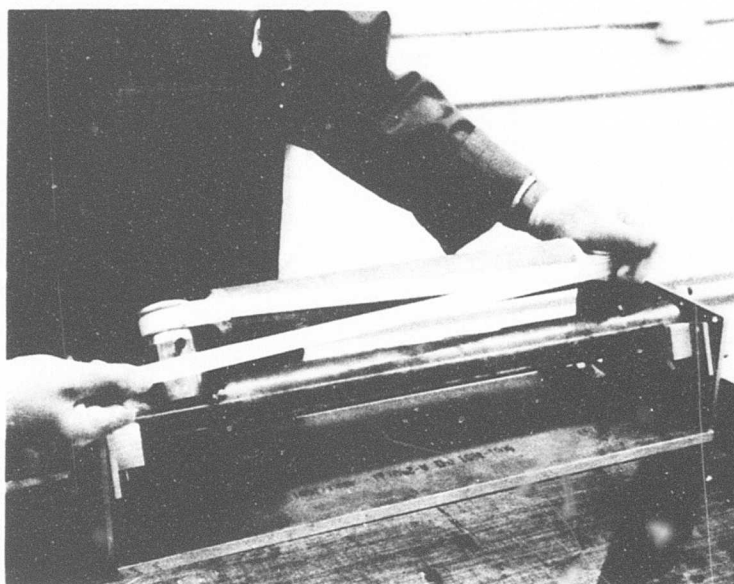
Figure 30. Assembly of Connecting Link.

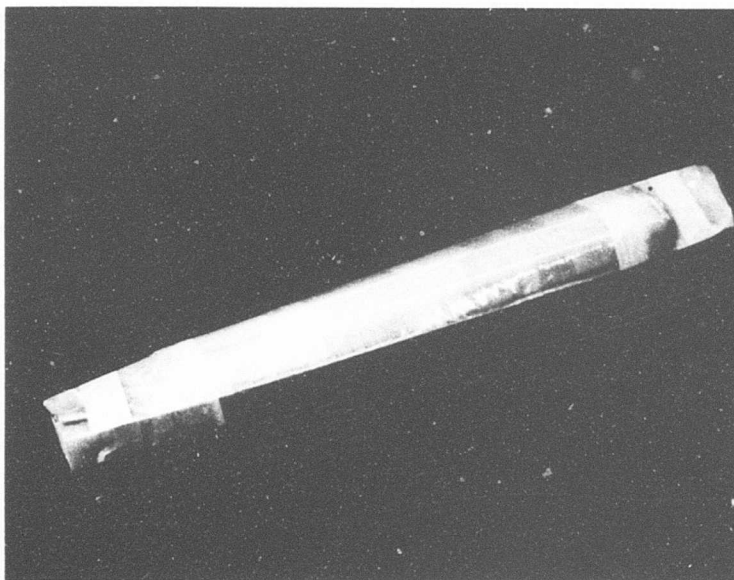
Figure 31. Connecting Link Wrapped With Shrink Tape Prior to Cure.

Curing of the unidirectional glass strap is accomplished by first applying cork dams on either side of the strap and overwrapping with cellophane shrink tape (Figure 31). The entire assembly is then placed in a 250°F oven and cured for 1 hour. After curing, the cellophane shrink tape and cork dams are removed and the detail deflashed prior to press fitting the swivel bearings.

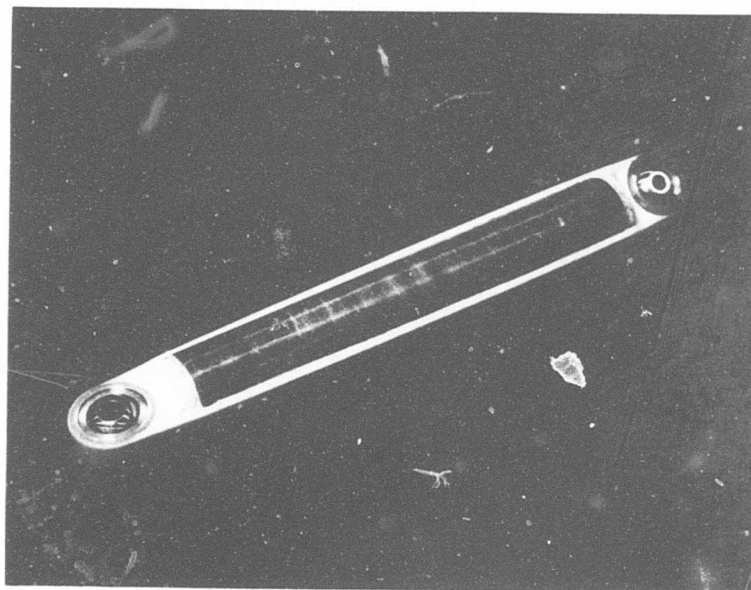
Figure 32. Full Assembled Connecting Link Component.

Figure 32 is a picture of a fully assembled connecting link component.

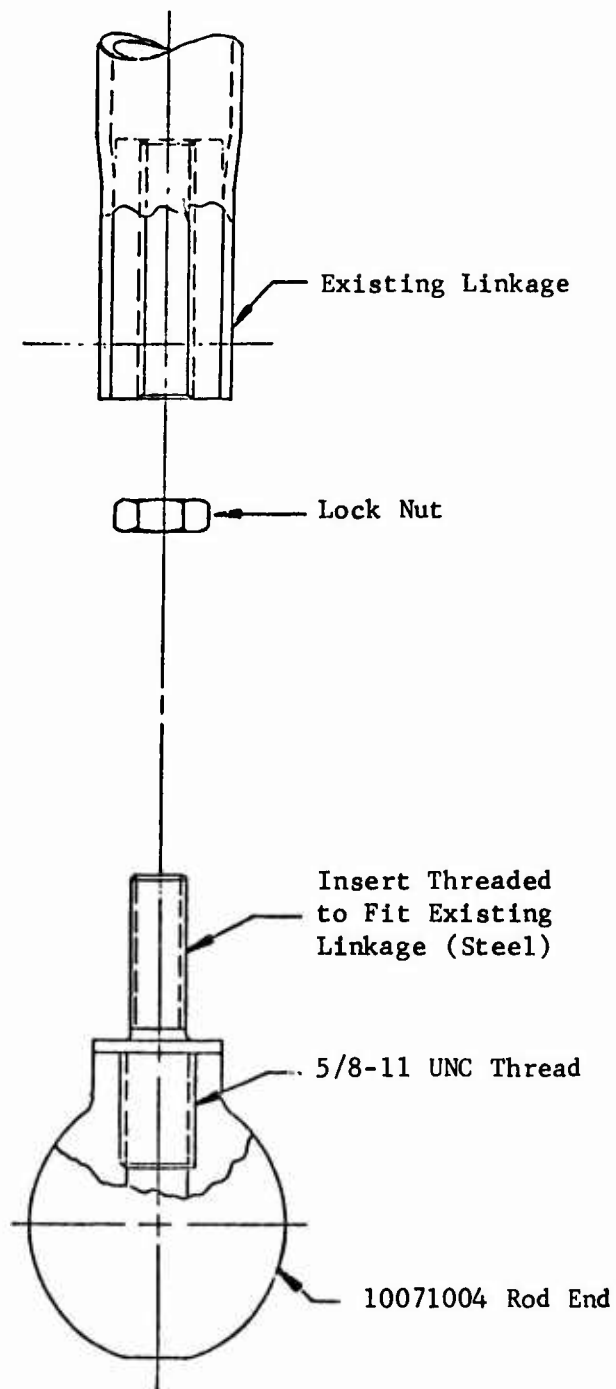
Figure 33. Modified Ball Rod Ends for the Aft Bell Crank Assembly.

A modified aft bell crank was designed and fabricated to better satisfy the fit and function requirement. The redesign involved the ball rod end attachment only. As discussed in the Test section, the aft bell crank assembly could not be installed due to the excessive length of the two ball rod end assemblies attached as appendages to the bell crank box. The redesign incorporated a different method of attachment between the ball rod ends and the connecting rods which they actuate. Figure 33 is a schematic of the typical modified ball rod end. It is approximately 10 inches shorter than the previous rod end design. It

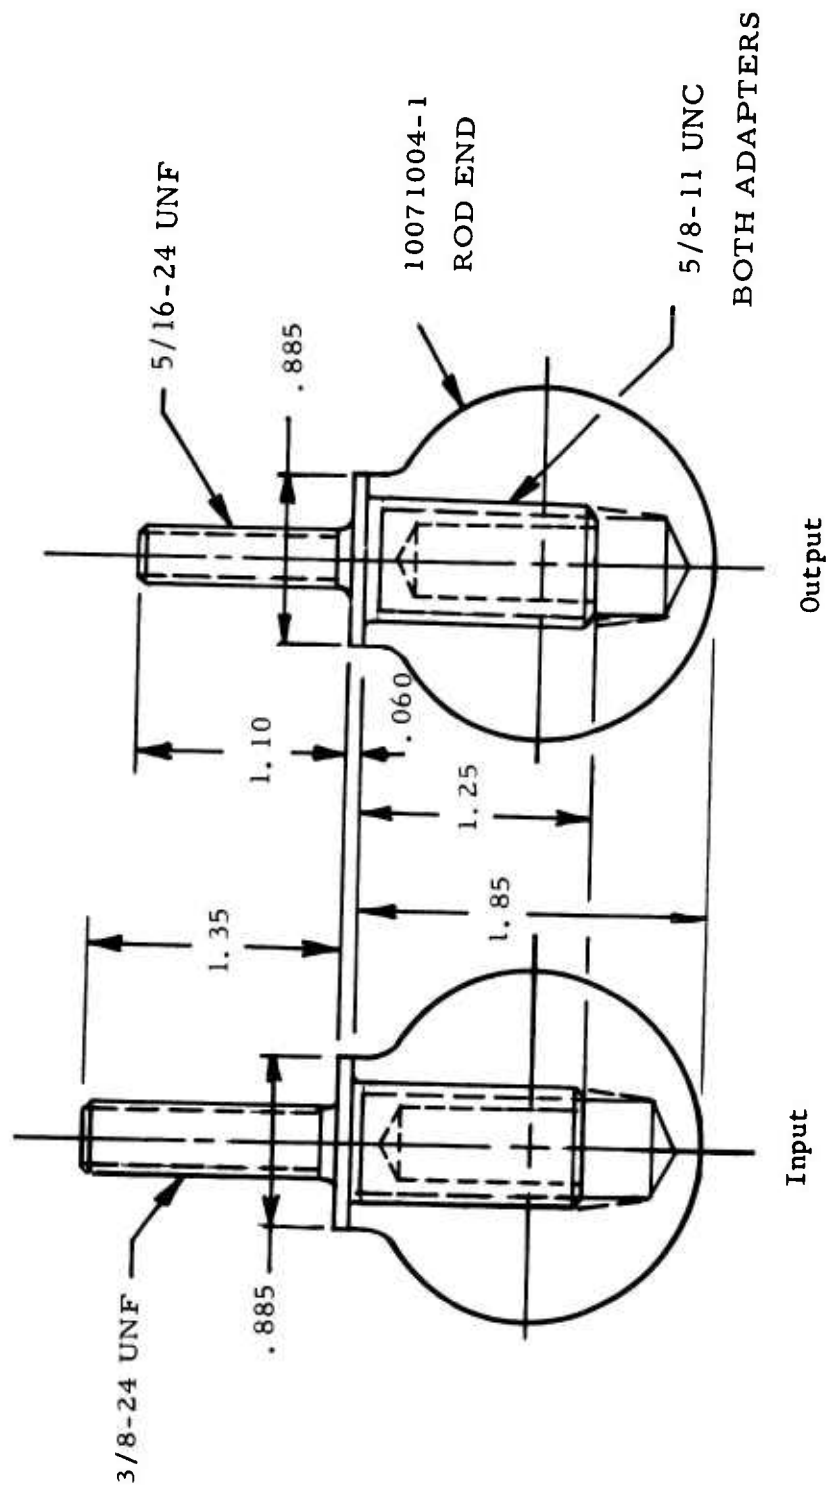
Figure 34. Modified Ball Rod Ends With Adapters.

incorporates a direct attachment to the connecting rods through a metallic insert threaded and bonded directly into the center of the ball. Since the shaft and thread dimensions for the two ball rod ends were different for the input and output ball and socket joints, two adapters needed to be fabricated. Figure 34 is a view of the two modified ball rod ends which were incorporated in the modified aft bell crank assembly.
